Safety Improvements of Black Spot Intersections in Lampang Municipality

Thodsapon Hunsanon
Nopadon Kronprasert
Auttawit Upayotin
Akhrapong Tepkaew

Department of Civil Engineering, Faculty of Engineering
Chiang Mai University

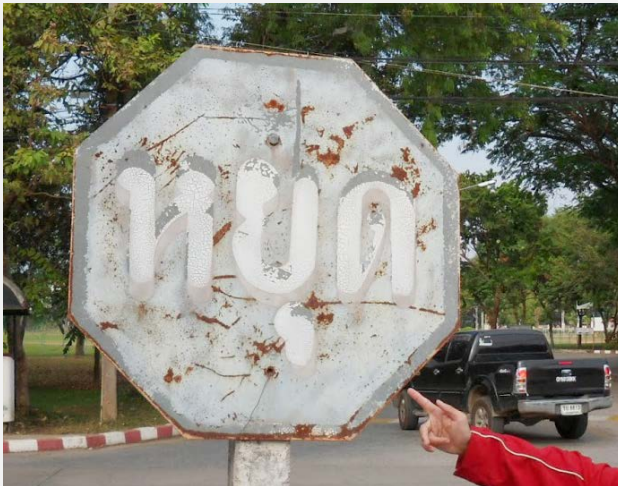
Poor condition of signage

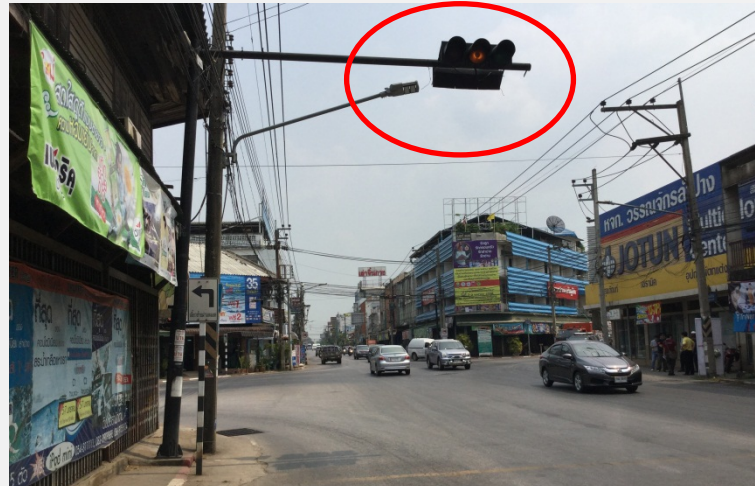
Poor visibility of traffic light

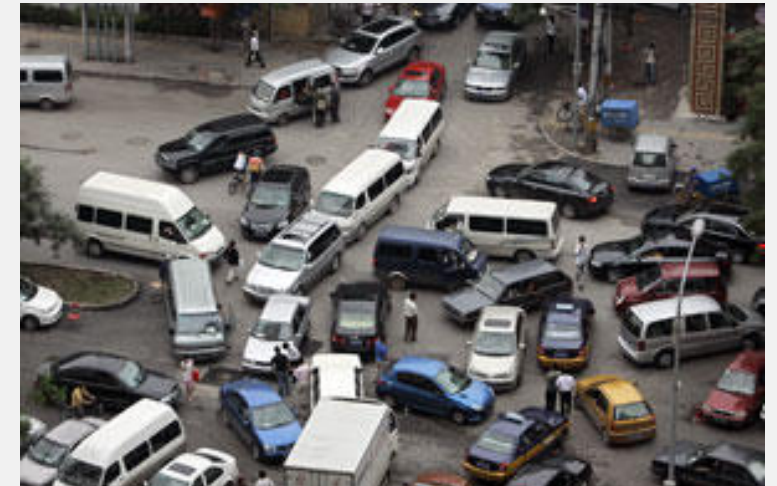
Poor intersection design

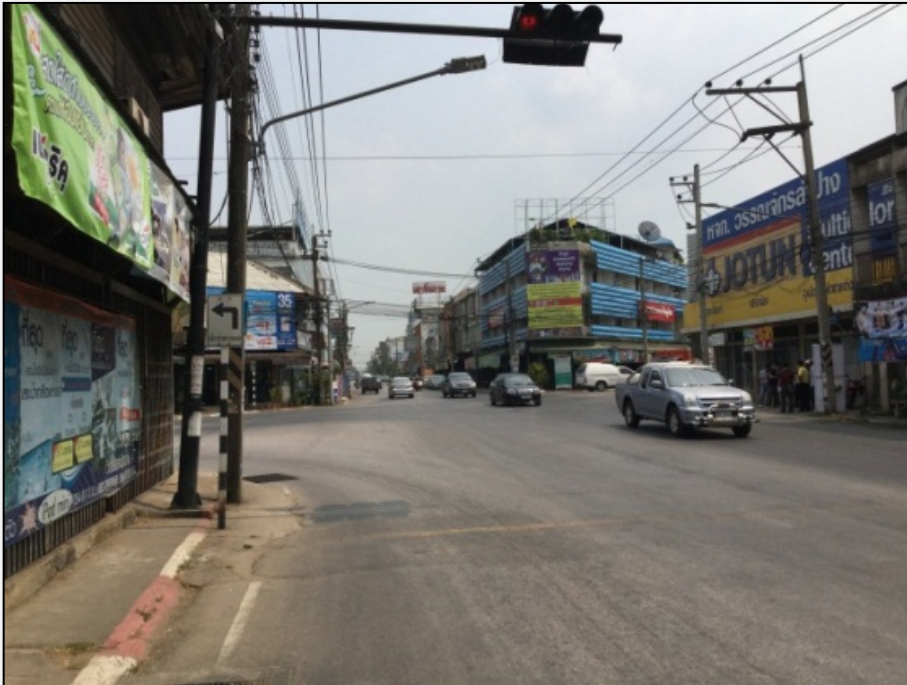
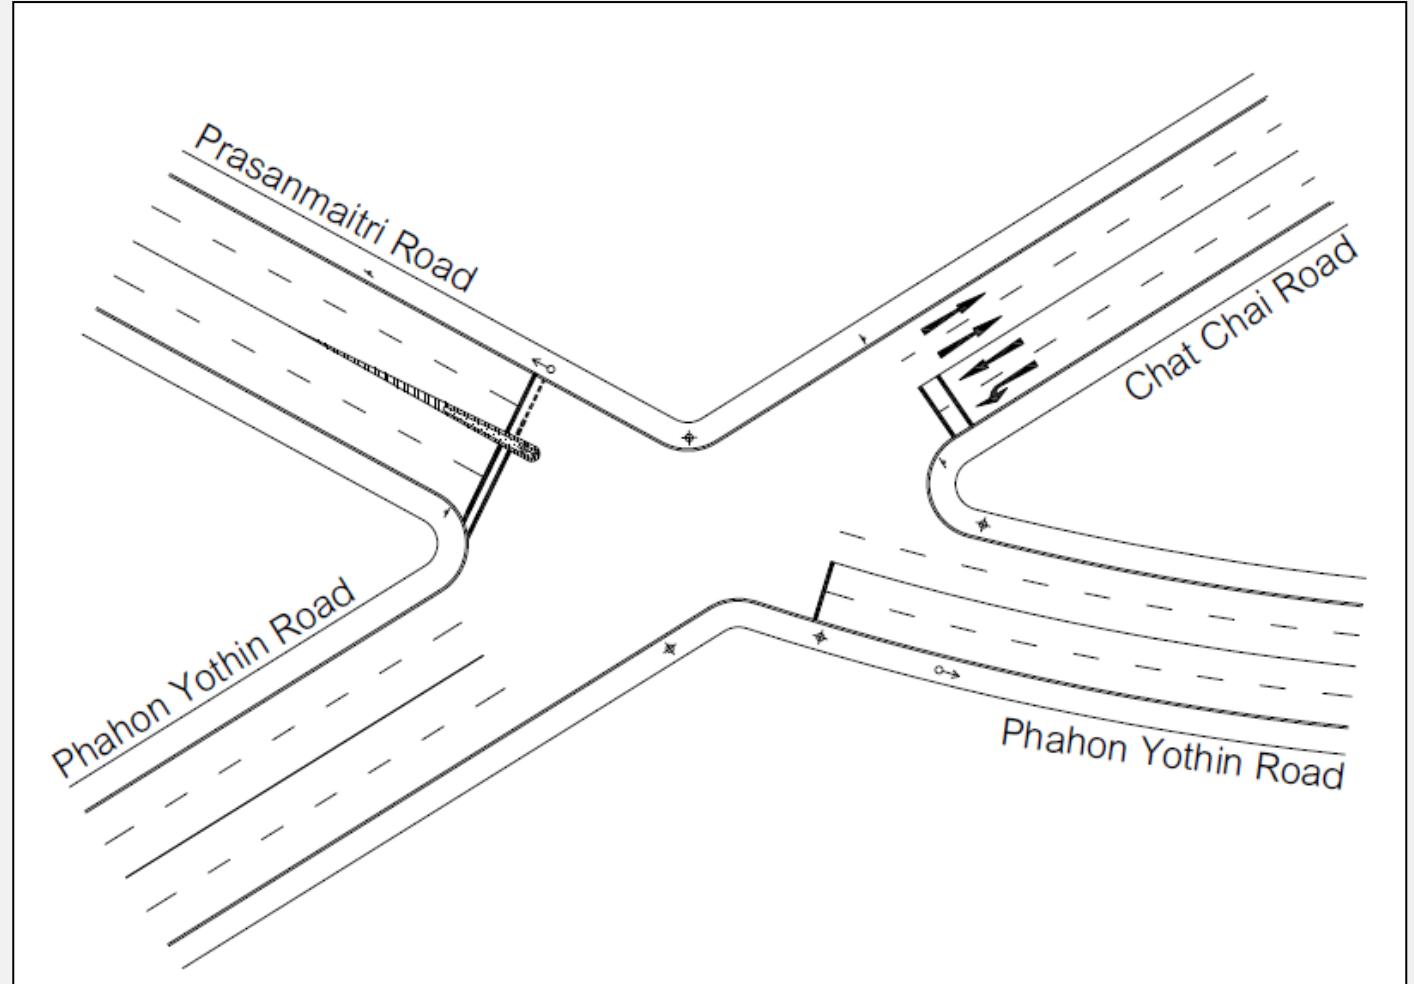
Don Pan Signalized Intersection

Safety Problems (High Risk Level)

- Intersection area is very wide
- Turning radius
- Insufficient sight distance

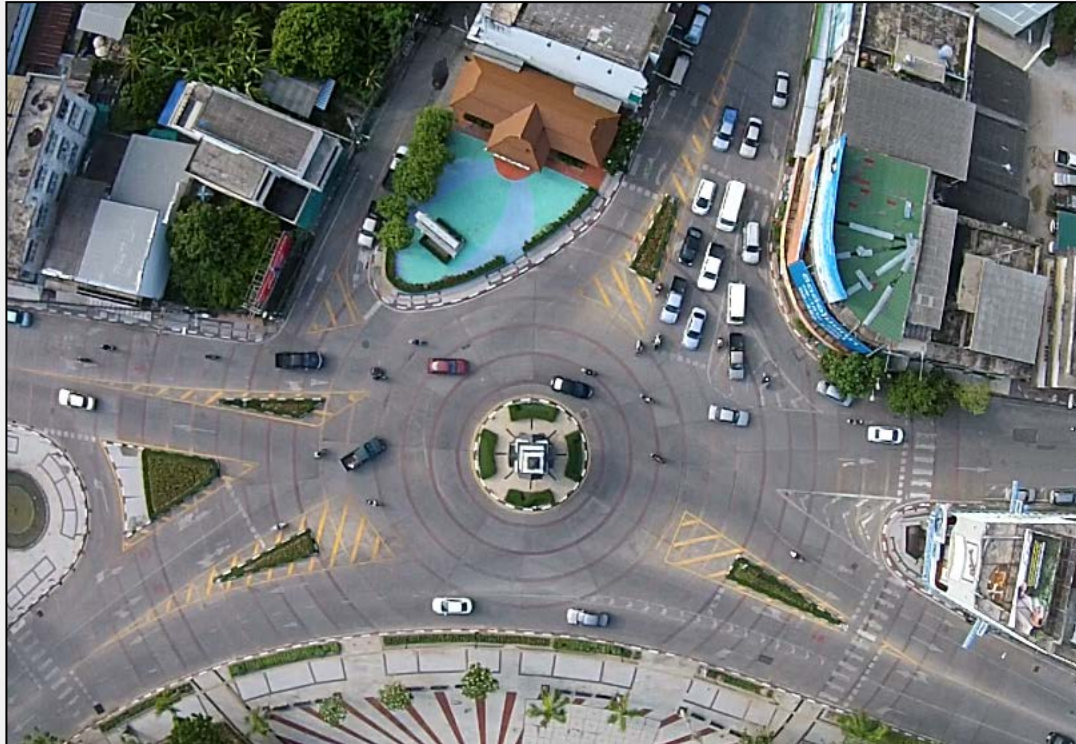
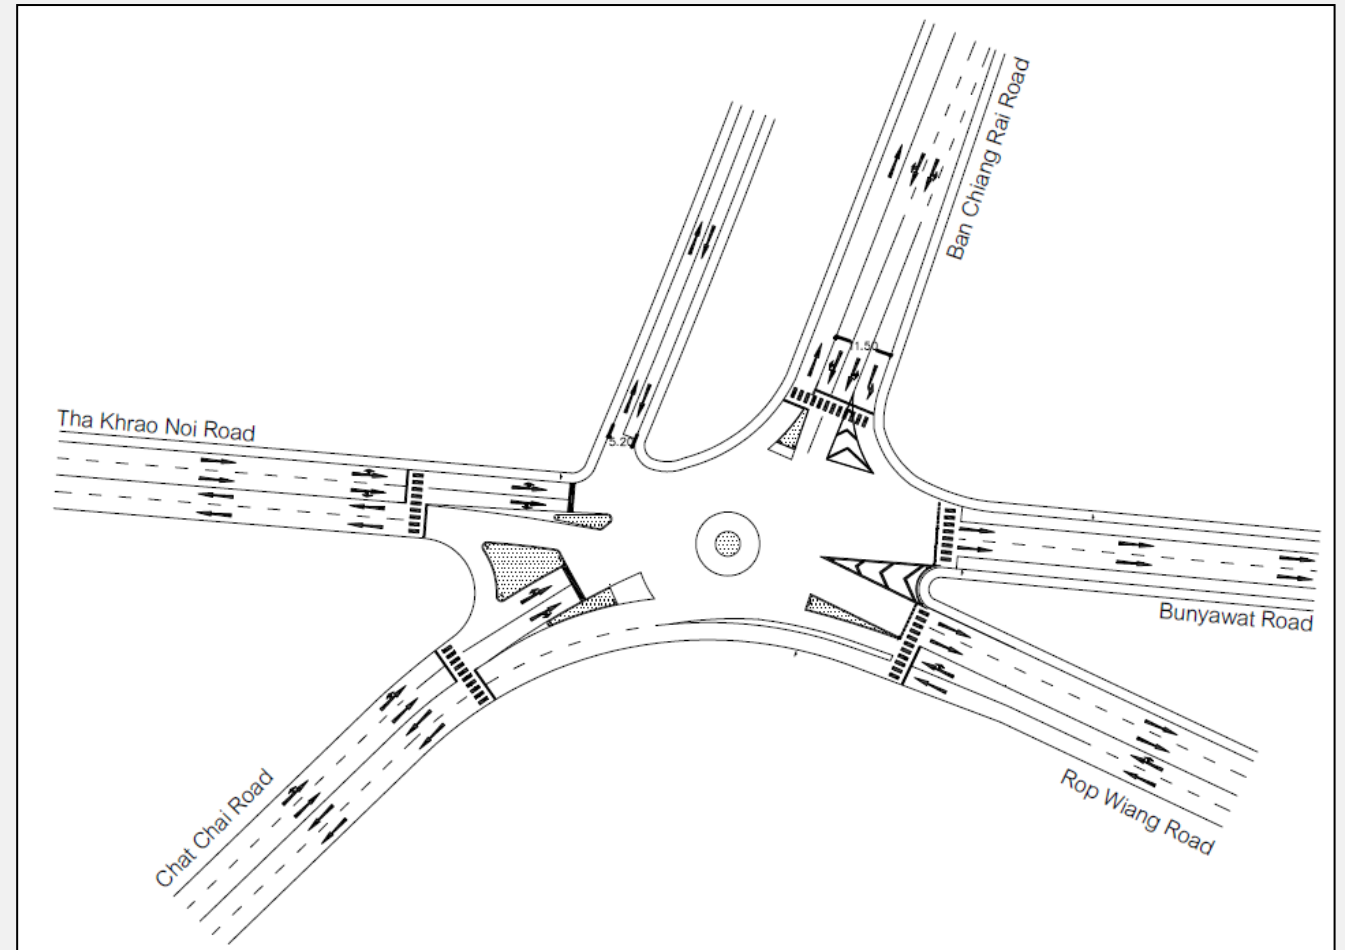
Clock-tower Roundabout Intersection

Safety Problems (Medium Risk Level)

- Unsymmetrical intersection
- A number of entrance and exit lanes is not equal.

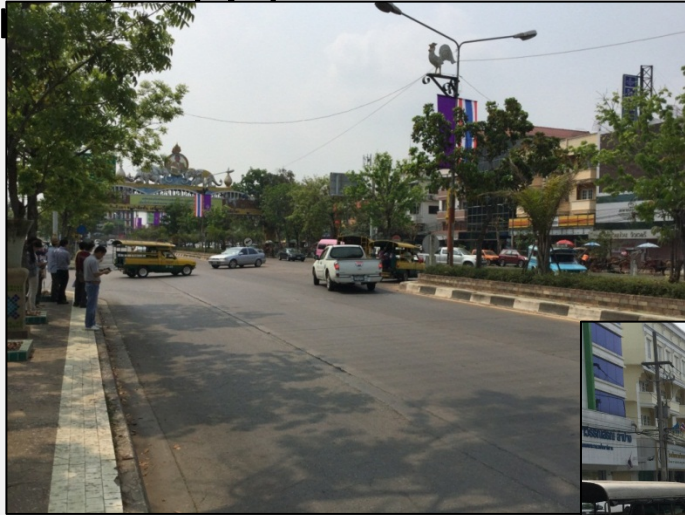
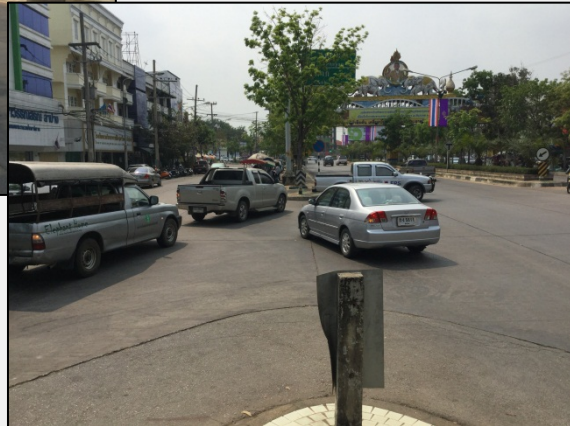
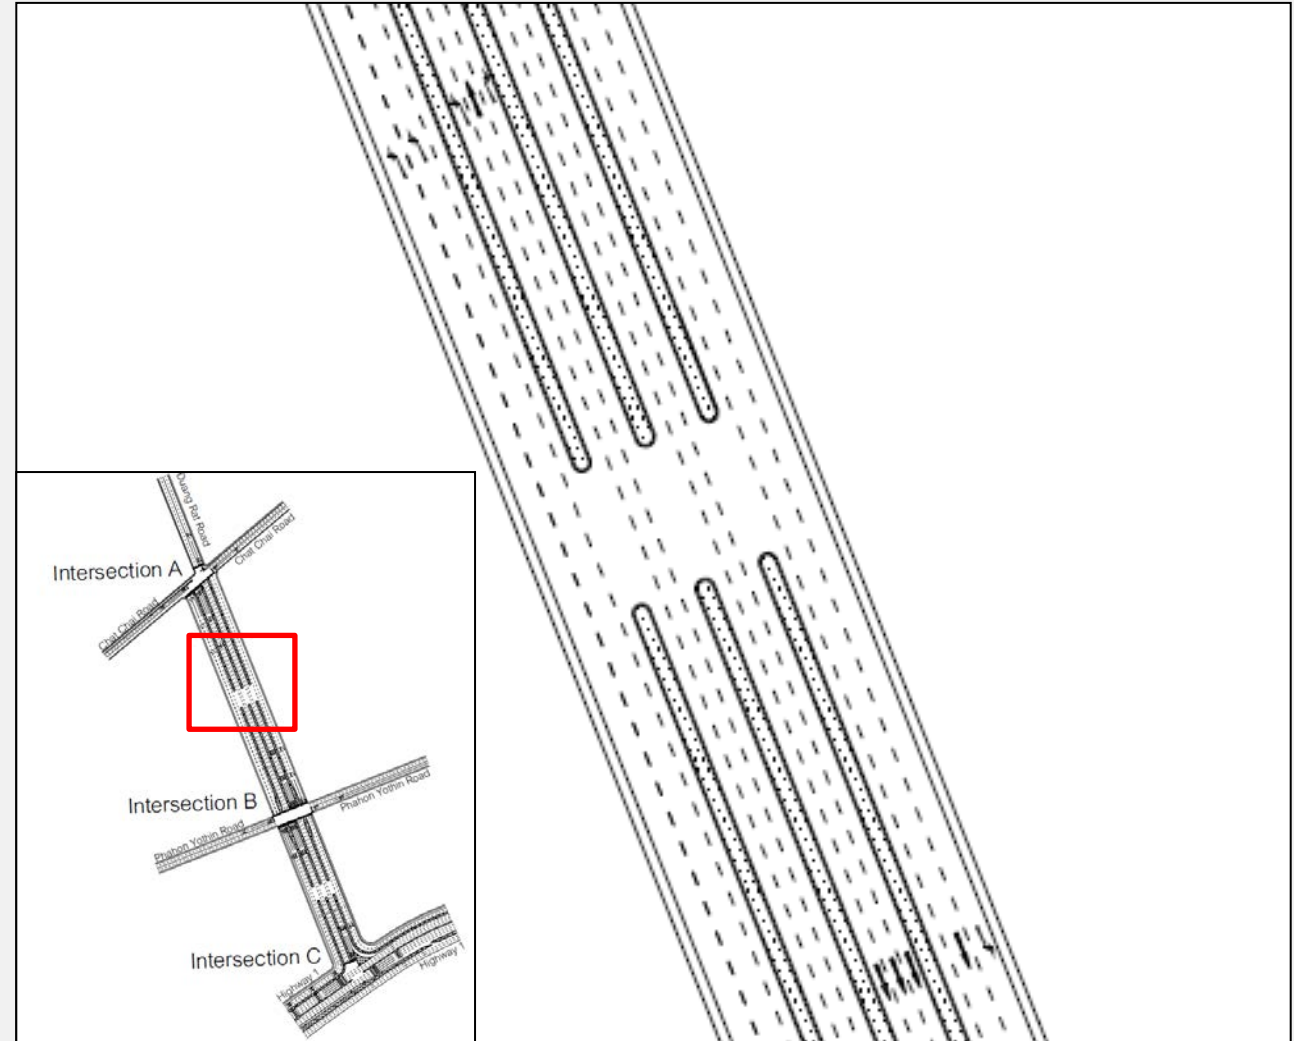
Median-openings on Duang Rat Road

Safety Problems (High Risk Level)

- Five conflicts at the median opening
- The median-opening space is wide
- The U-turn vehicles obstruct the main
